Analysis of pathological manifestations of a stretch of Avenida Perimetral in Belém, Pará, Brazil – A case study

Alex Geovany da Silva Miranda¹, Glauciane Santos da Silva²

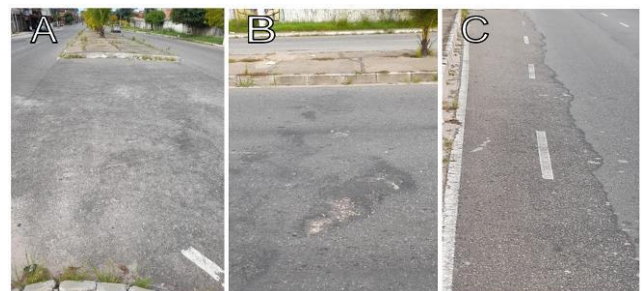
Fig.7 - (A) Wear; (B) Exudation; (C) Surface patch.

In subsections 1 and 6, areas affected by the effect of the progressive pulling of aggregates from the pavement were found. Characterized by surface roughness of the coating, due to tangential efforts of intense traffic in return and shoulder areas, this pathology is called wear, fig. 7A.

Areas affected by exudation, in the transverse direction of the road, were identified in subsections 2 and 4. This pathology is characterized by excess bituminous binder on

the surface of the pavement, caused by the migration of the binder through the coating. This pathological manifestation is very common after the "hole cover" operation - fig. 7B.

It was found in subsections 3 and 12 the existence of a long understanding of the surface patch. It is a correction, in an area located on the surface of the coating, by the application of a bituminous layer. Deep patching was not observed in the study section, that is, when the coating is replaced - fig. 7C.

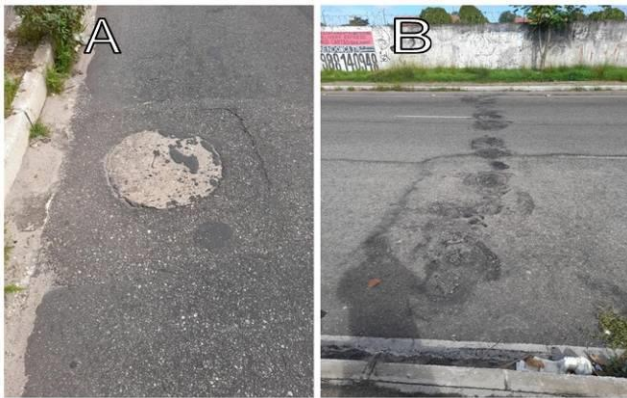
Fig. 8 - (A) Local plastic sinking; (B) Degradation of the ligand.

In subsections 5 and 10, cases of local plastic sinking were identified. It is a pathology caused by the plastic creep of one or more layers of the pavement or subgrade, in this case, accompanied by lifting, as can be seen in Fig. 8A.

According to Portal G1 (2021), in December 2021, residents of the Terra Firme neighborhood, in protest, set fire to tires and pieces of wood, on Perimetral Avenue - fig. 8B. This fact exposed the asphalt pavement to the action of high temperatures, with degradation and disaggregation of the bituminous material (binder). This exogenous pathology was identified in subsection 7.

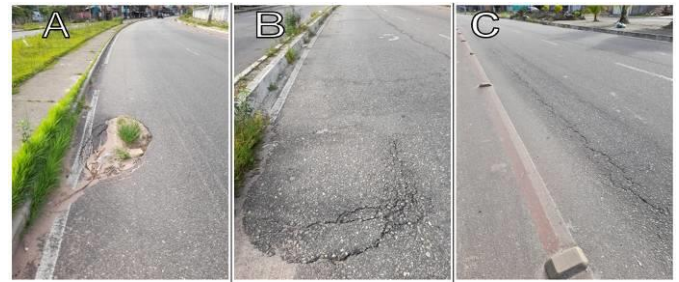
Fig. 9 - (A) Pot or hole; (B) Block-type crack; (C) Long longitudinal crack.

Pot or hole is the cavity that forms in the coating for various reasons and can reach the lower layers of the pavement, causing the disaggregation of these layers, as in this case, identified in subsection 8, where the exposure of the lower layer of the pavement can be seen, fig. 9A.

In subsection 9, the existence of block-type cracks was identified. It is a set of interconnected cracks, characterized by the configuration of blocks formed by well-defined sides, fig. 9B.

When the crack is isolated, presenting a direction predominantly parallel to the axis of the track, whose extension is greater than 100 cm, it is called a long longitudinal crack - fig. 9C. This pathology was identified in subsection 11. It is noteworthy that Perimetral Avenue has an intense flow of heavy vehicles, such as buses and trucks.

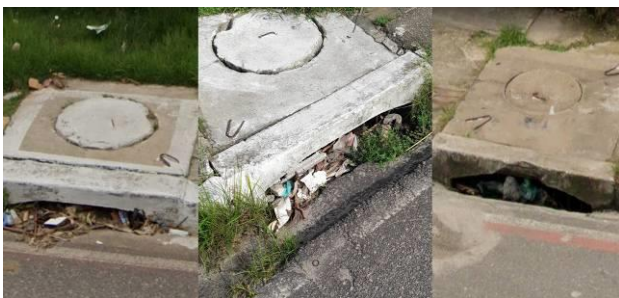
Fig. 10 - Accumulation of solid waste in storm drains.

Table 2 shows that the accumulation of solid waste and obstruction of storm drains was recorded in the 12 subsections. Such pathologies overload the drainage system, facilitating the accumulation of water and flooding, fig. 10.

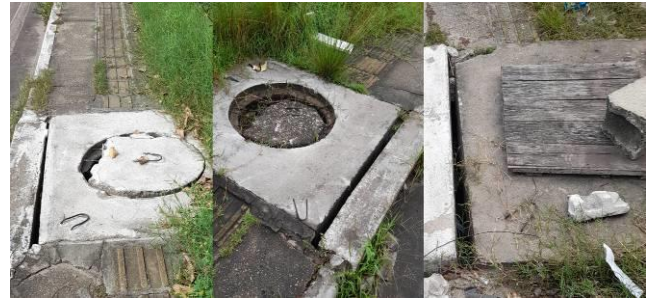
Fig. 11 – Wolf mouths with broken or missing lid

In subsections 2 and 4, almost all storm drains have a broken or missing concrete cover. In this case, the surrounding residents themselves provide some palliative form, such as a wooden cover. Also note the displacement of structural parts of the storm drains, fig. 11.

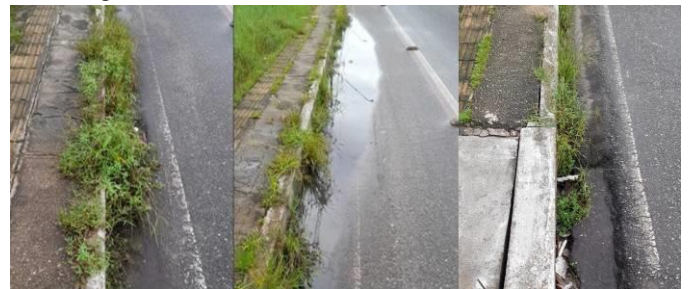
Fig.12 – Gutter silting.

It was observed in subsection 9, the silting of the gutter, caused by the presence of vegetation and solid residues, such as sand. This pathology causes water retention, which often invades the track, providing a dangerous state for the rolling of vehicles that need to slow down, fig. 12.

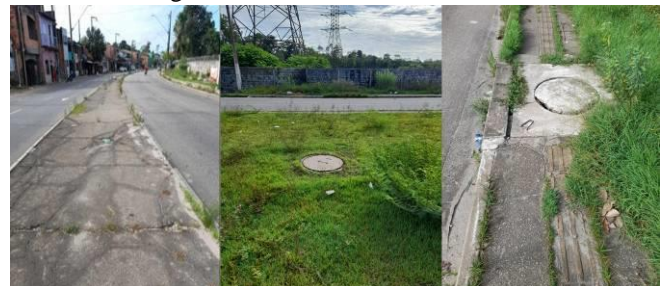
Fig. 13 - Degradation and presence of vegetation on the pavement.

The pavement, in the study section, presents itself with vegetation and debris, impairing the mobility of pedestrians. Tactile floor boards for accessibility are practically useless. The central bed of the avenue, in subsection 10, shows degradation, with pronounced cracks and erosion, Fig. 13.
